**ENGINEERING EVALUATION AND COST ANALYSIS
FOR THE FORMER USS WASHTENAW COUNTY (LST-1166)**

REVISION 2

May 24, 2011

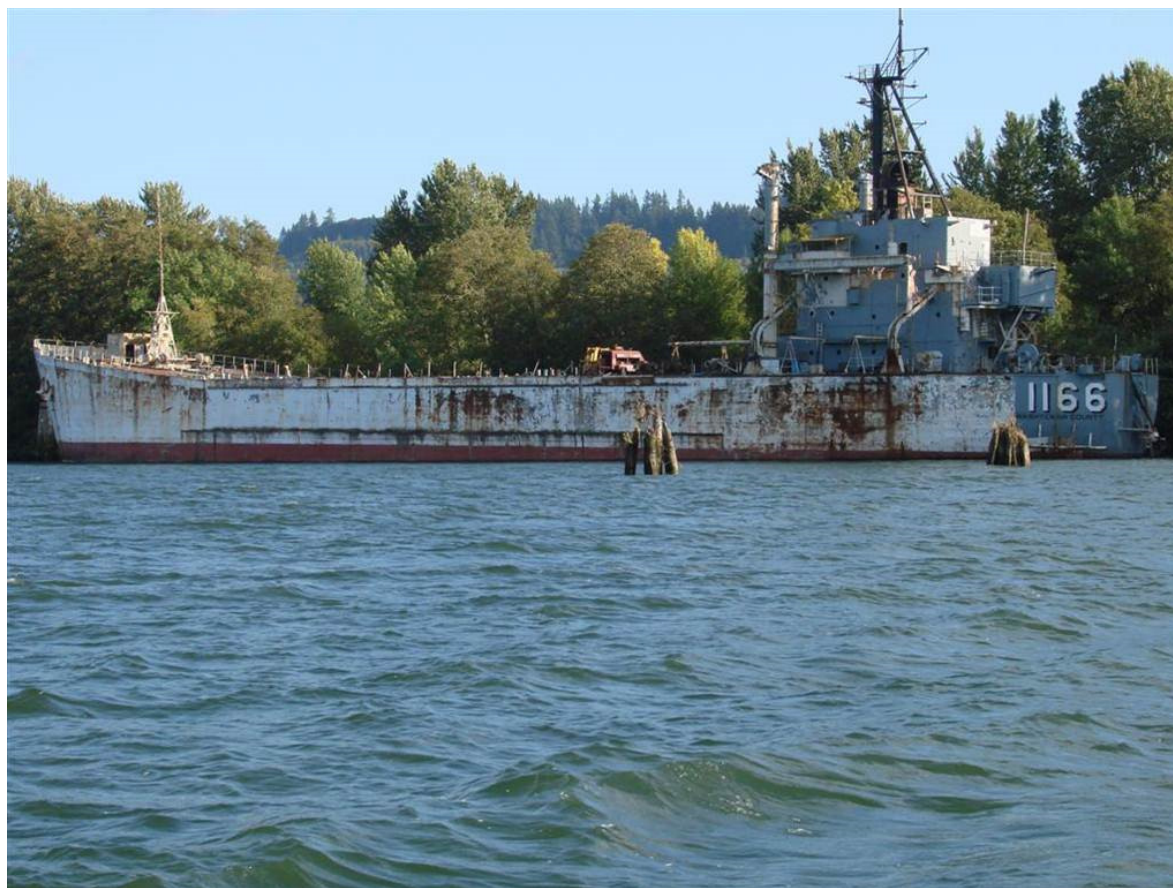
Photo 2: Port View

Trespassing aboard the vessel appears to have begun in 2004. Reports of vandalism, illegal methamphetamine activity, illegal dumping of waste oil and stripping and theft of metal, wiring, piping, hatches and valves have since occurred (EPA 2010b). Photographs 2 through 6 document existing conditions.

The LST-1166 hull has deteriorated and the vessel has taken on water from a leaking seal. The bottom two decks and the engine room are flooded (EPA 2010b) and the hull rests on the river [NUS]bed.

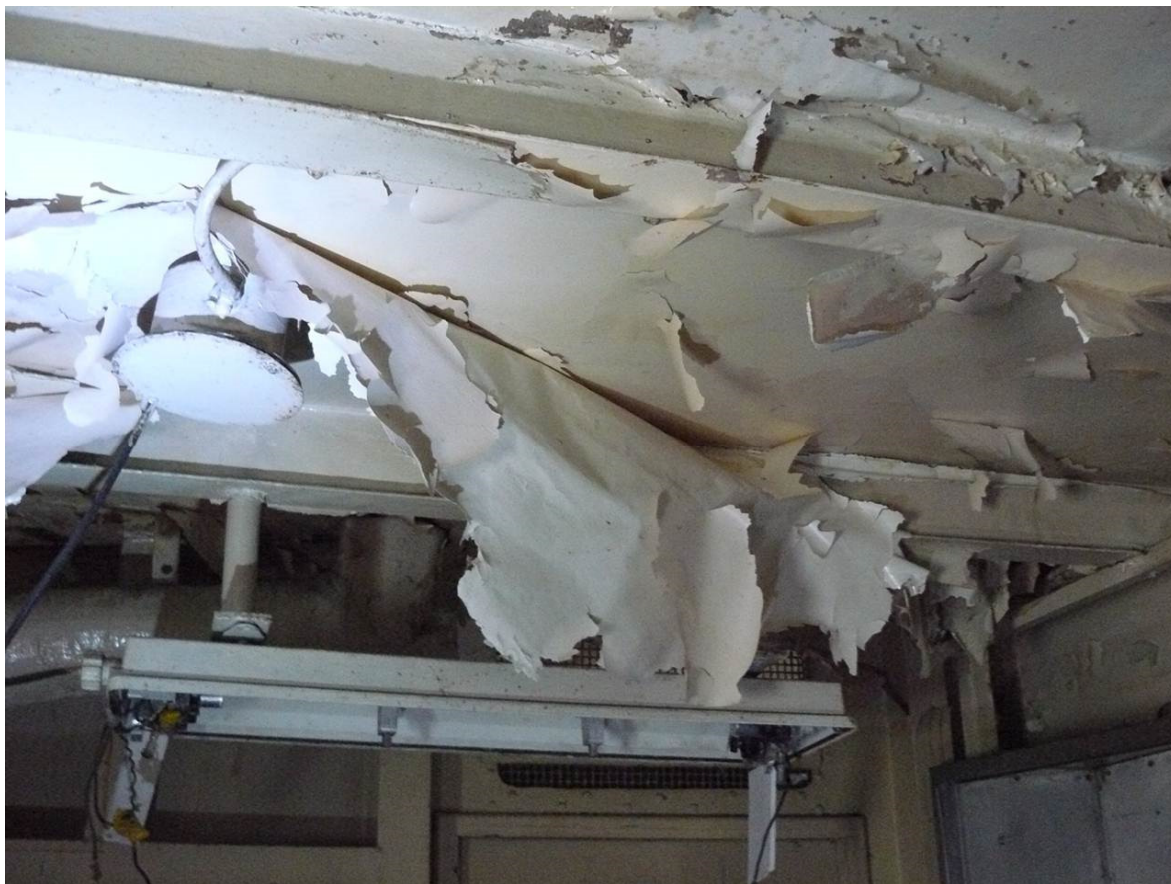
Photo 4: Flaking Ceiling Paint

During inspections conducted by EPA in January and March 2010, painted surfaces throughout the interior and exterior of the vessel were observed to be corroding and flaking, with paint chips littering most horizontal surfaces and deck floors (Photographs 4 and 5). In addition, there ~~was~~ the potential for paint flaking off of external surfaces and the hull ~~and falling to fall~~ into the Columbia River, however this appeared unlikely without some abrasive force. Correspondence between USCG and EPA confirmed that the interior paint contained both lead and PCBs, while the exterior paint contained only lead. On October 9, 2008, Crescere Marine Engineering, Inc. conducted an estimate of total surface area for paint removal from the vessel. The total paint removal area, including all interior and exterior areas of the vessel, was estimated at 519,456.5 square feet. The total paint removal area, excluding the exterior of the vessel, was estimated at 447,337.8 square feet.

- a. Chips of flaking paint were observed on the deck and walls in the superstructure. These paint chips will be removed and properly disposed off- site.
- b. There were several capacitors in the officer's area which will be removed from the vessel.

Loose friable and paint chips will be vacuumed from floors and surfaces of the interior of the vessel. A HEPA-equipped vacuum will be used for this cleanup. The waste will be collected in 55-gallon drums which will be transported by trucks to an off-site permitted landfill for disposal.

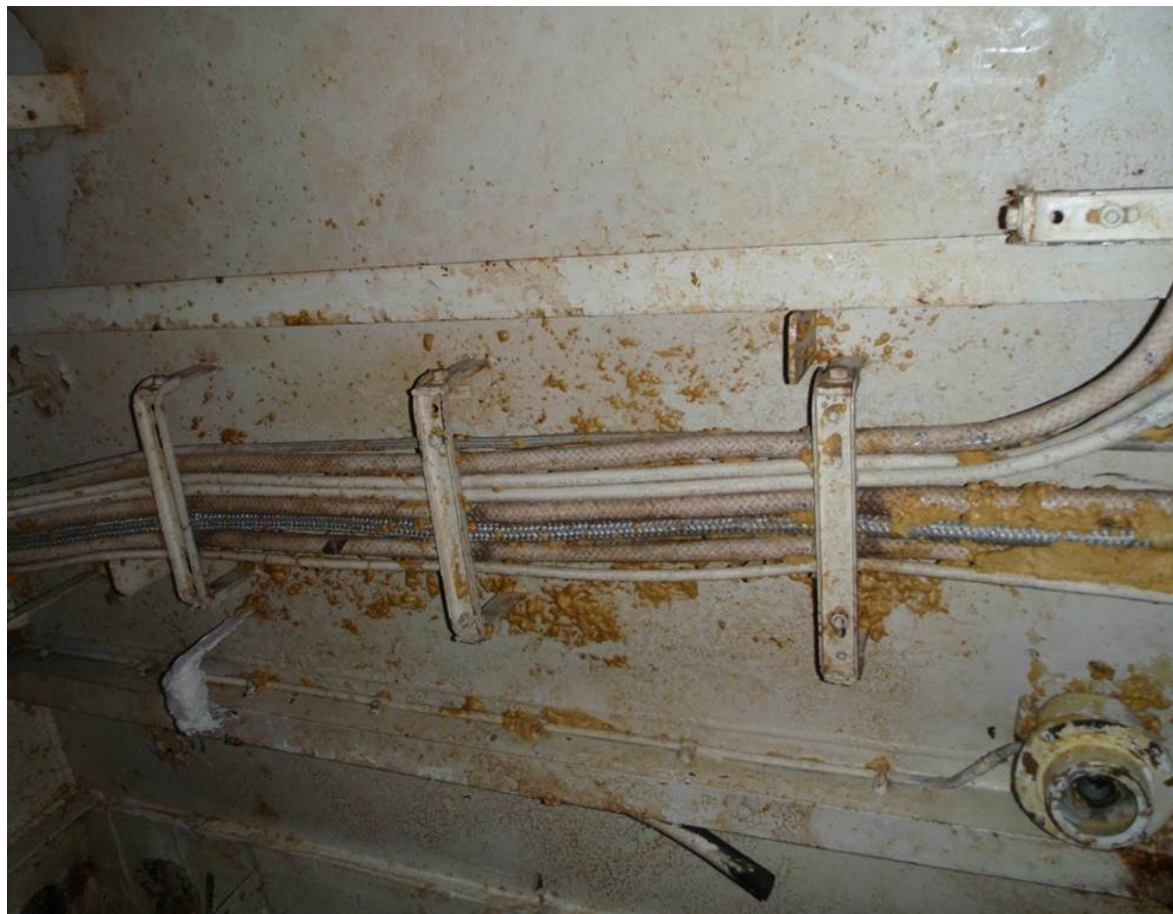
Photo 6: Jacketed Electrical Wiring

Through correspondence with the USCG, EPA confirmed that the wiring was of an age where asbestos-insulation on and ~~ed and contained hazardous amounts of~~ PCBs would be expected. Most of the easily accessible wiring in the vessel ~~has been was~~ removed by scavengers for the recyclable copper content. The electrical wiring that remains (estimated at 60 pounds) contains concentrations of PCB that range from <0.50 milligrams per kilogram (mg/kg) to 2,160 parts per million (ppm^{NU9}). During the USCG's Removal Action, ~~that was~~ conducted in 2008 and 2009, insulation, surfaces, and piping that contained friable asbestos were encapsulated with a polymer. This encapsulated material was observed by EPA on board the vessel in 2010 and was estimated to be approximately 80 cubic yards in volume. In addition, asbestos flooring was present in the mess hall of the vessel.

- The volume of ACM was not quantified (e.g., floor tile, insulation, etc.) but is reported to be in non-friable condition (USCG 2009), friable ACM has been removed or encapsulated. Some of the wiring consists of copper wire wrapped in asbestos which is impregnated with PCB. The wire and wrapping is jacketed in a protective, braded cover and further covered by multiple layers of paint. The PCB and asbestos is not readily available to human health or the environment ([Photo 6](#)).
